Federal Lead Smelter - East Side
LPC# 1190105308/1191155020
Madison County
SF/HRS

CERCLA Site Investigation

Title: CERCLA Site Investigation for Federal Lead Smelter (ASARCO)-East Side

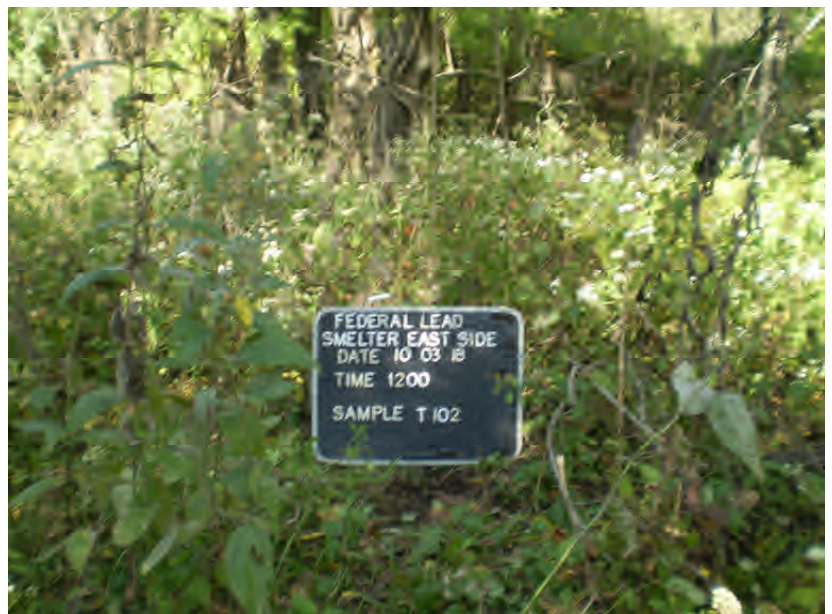
COMMENTS: T102 was collected from the same location as X111 & X112

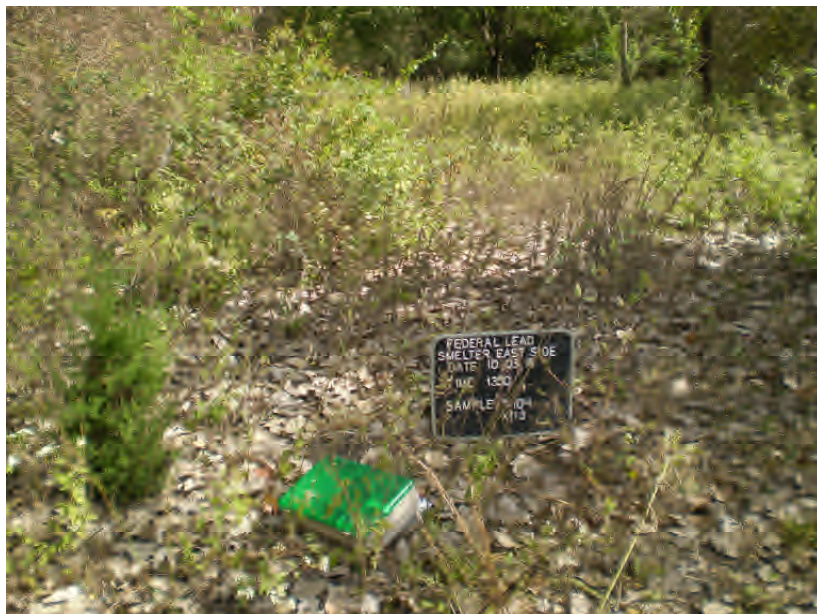
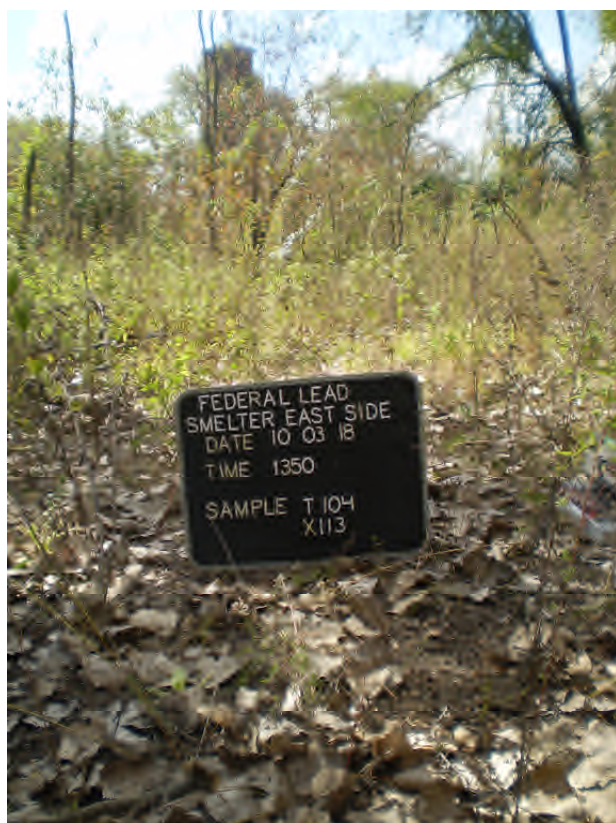
COMMENTS: Sample X113 was collected from fine silt material with trace cinders and slag chunks. TCLP sample T104 was collected from this same location.

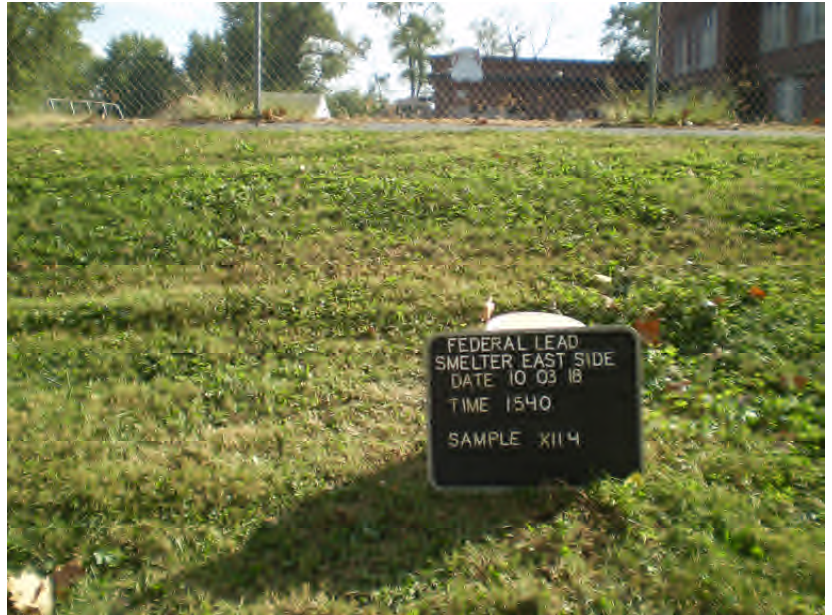
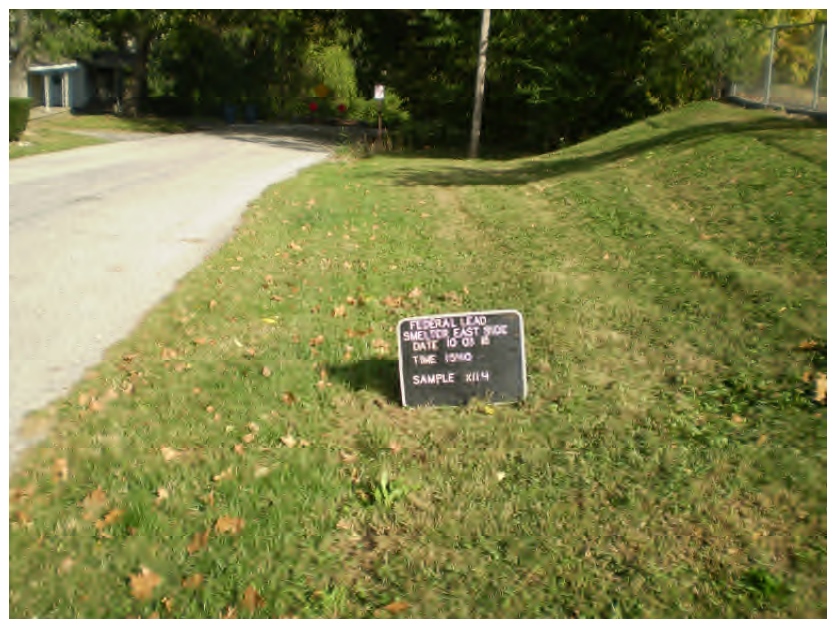
COMMENTS: Sample X114 was collected from 0-3 inches from the Clara Barton School. Light brown silt. This sample was used as the background sample.

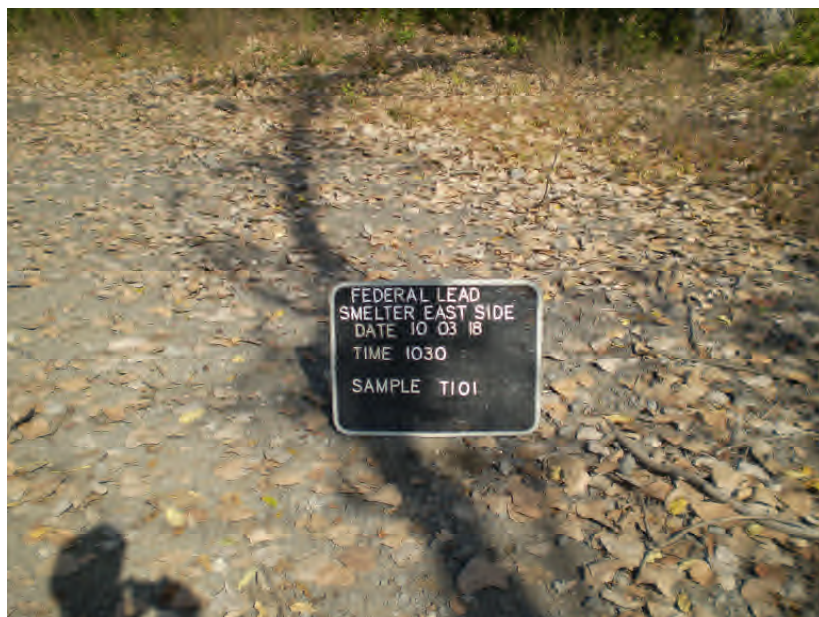
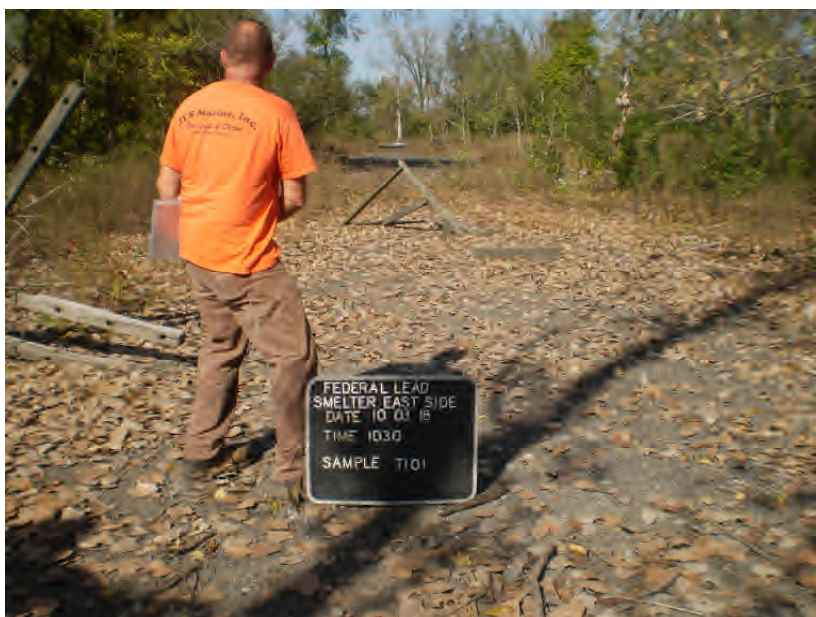
COMMENTS: Sample T101 was collected from 0-2 inches from the same location as X108.

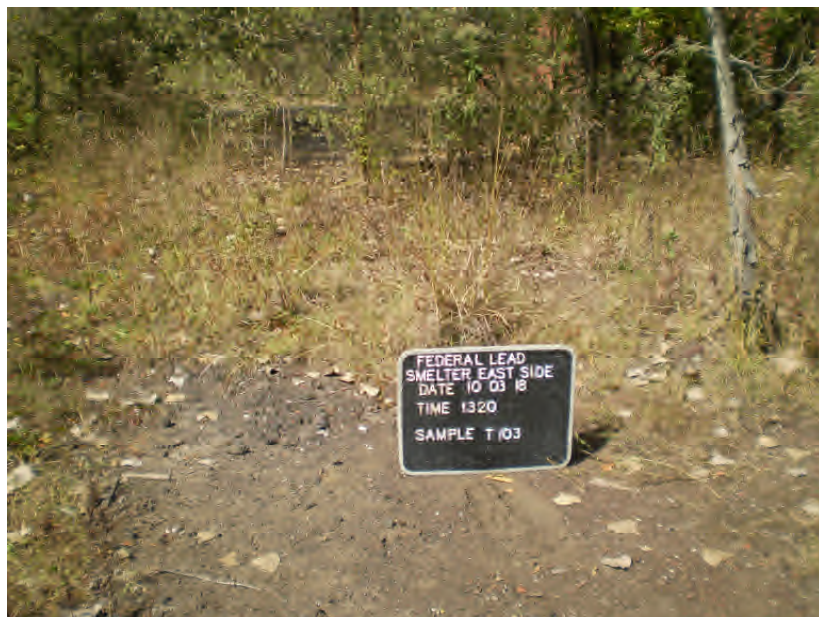
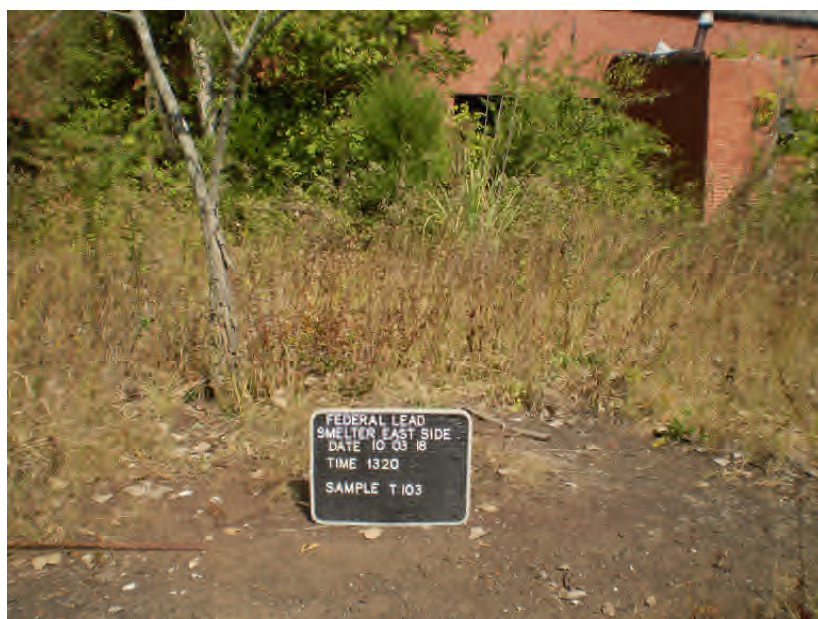
COMMENTS: Sample T103 was collected from sample X101 in waste material.

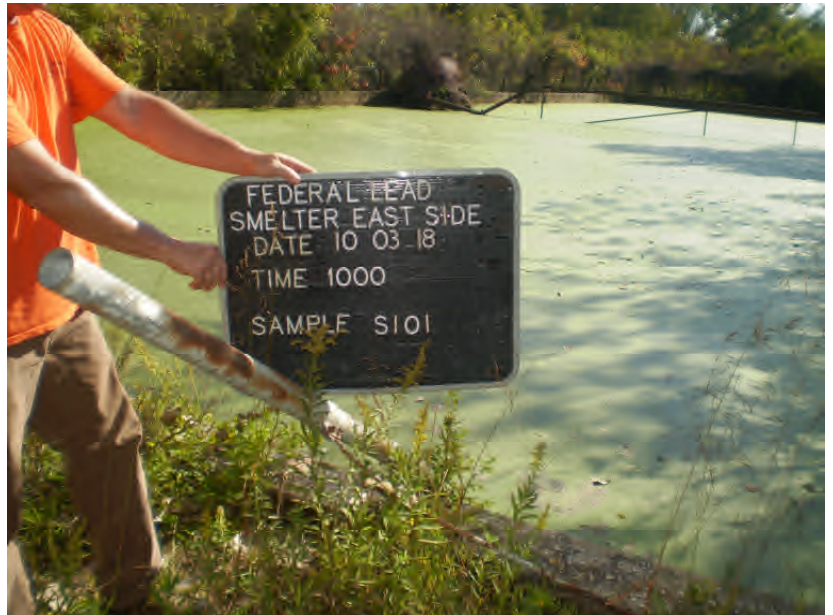
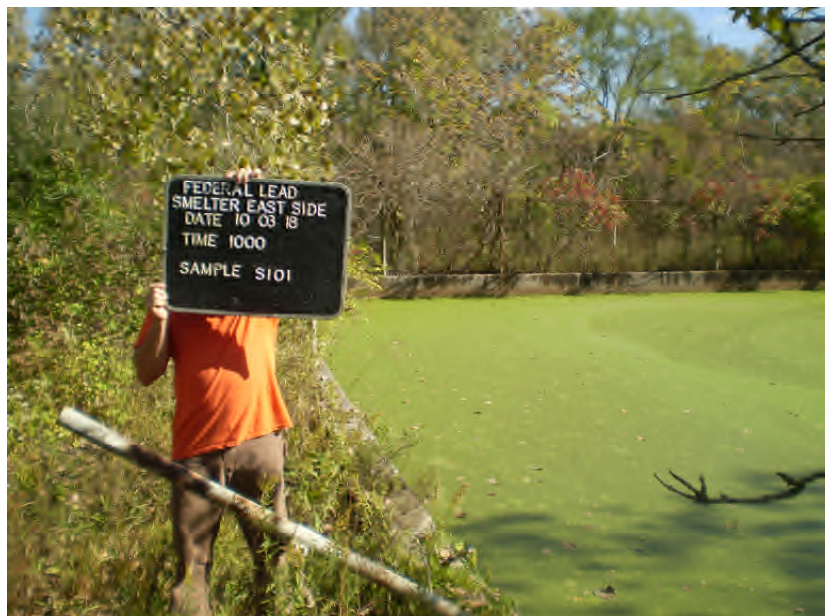
COMMENTS: Sample S101 was collected from the surface water impoundment located on site. The water was covered with duckweed and was fairly clear with no odor or sheen.

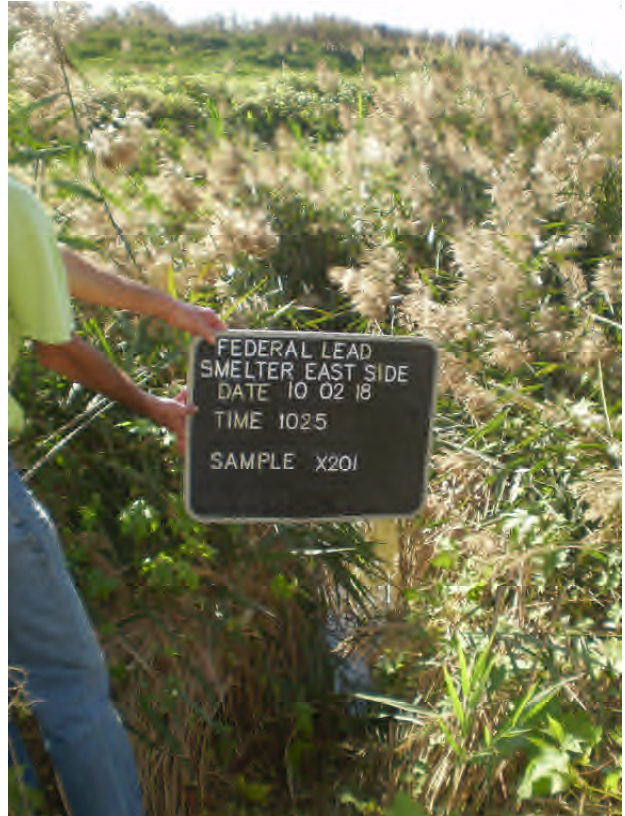
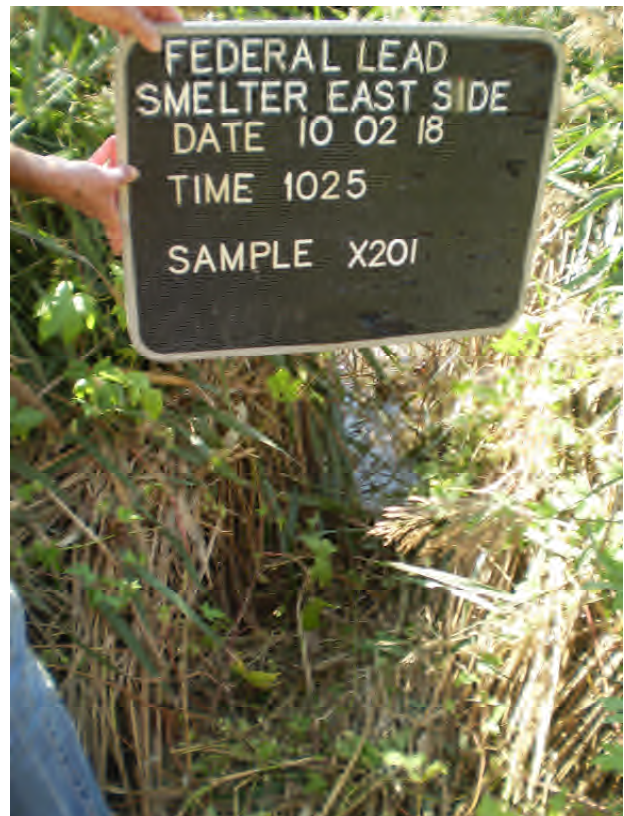
The sediment samples nearest the waste pile had the highest concentrations of metals that were also found on the waste pile samples. Sediment sample X201 & X202 had observed release concentrations of cadmium and zinc. Sample X201 contained 5.2 mg/kg of cadmium and 403 mg/kg of zinc. Sample X202 contained 4.3 mg/kg of cadmium and 402 mg/kg of zinc.

COMMENTS: Sample X201 was collected from the intermittent stream from 0-4 inches. Consisted of silty clay.

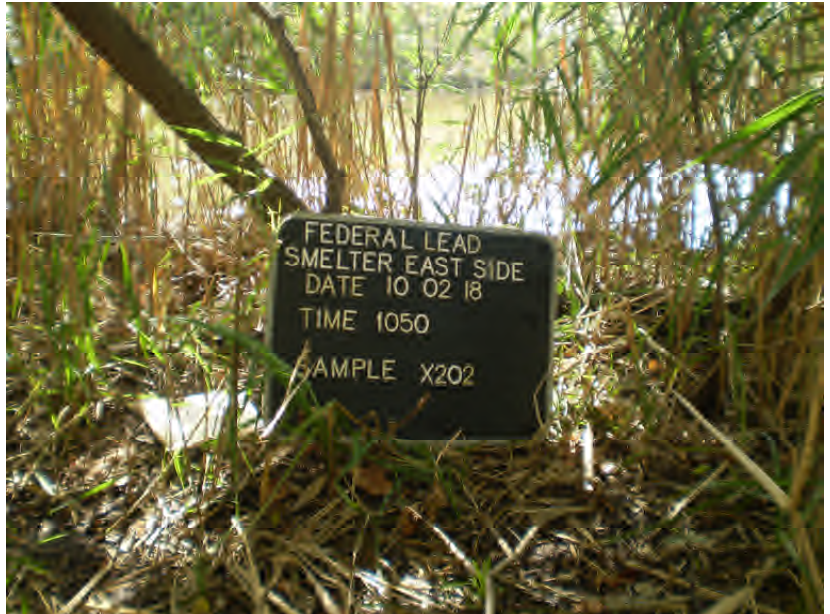
COMMENTS: Sample X202 was collected from the pond located on the south side of the site from 2-6 inches. Fine sand with some silt.

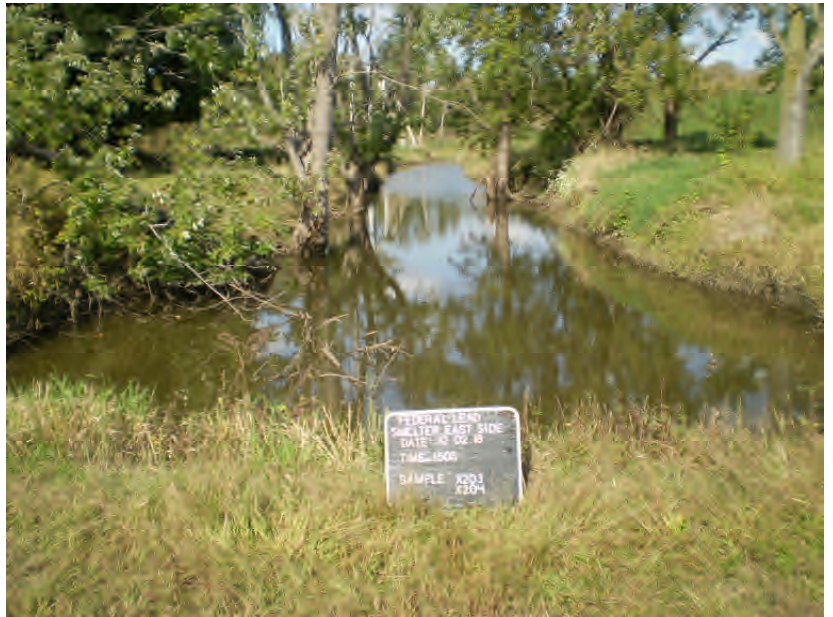
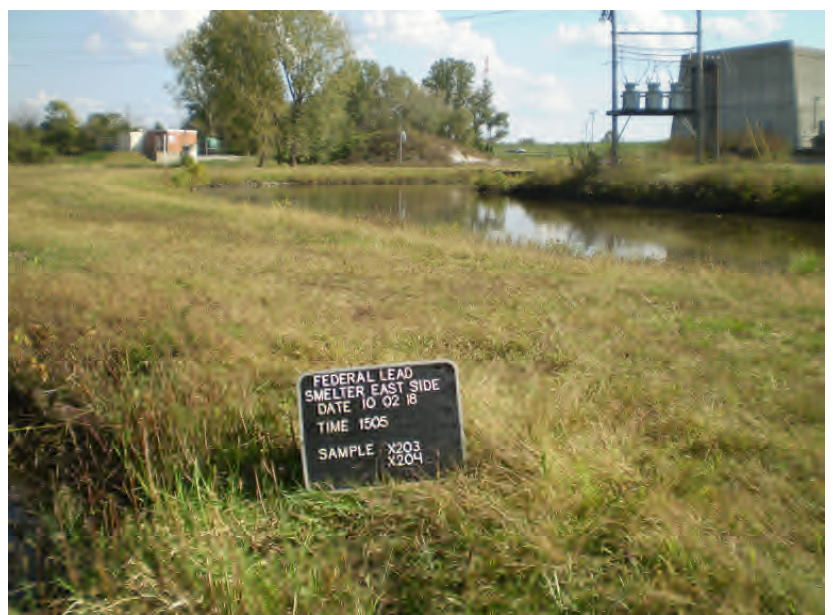
COMMENTS: Sample X203 & X204 were collected from the end of the ditch that enters a perennial waterway. was collected from the pond located on the south side of the site from 2-6 inches. Fine sand with some silt.

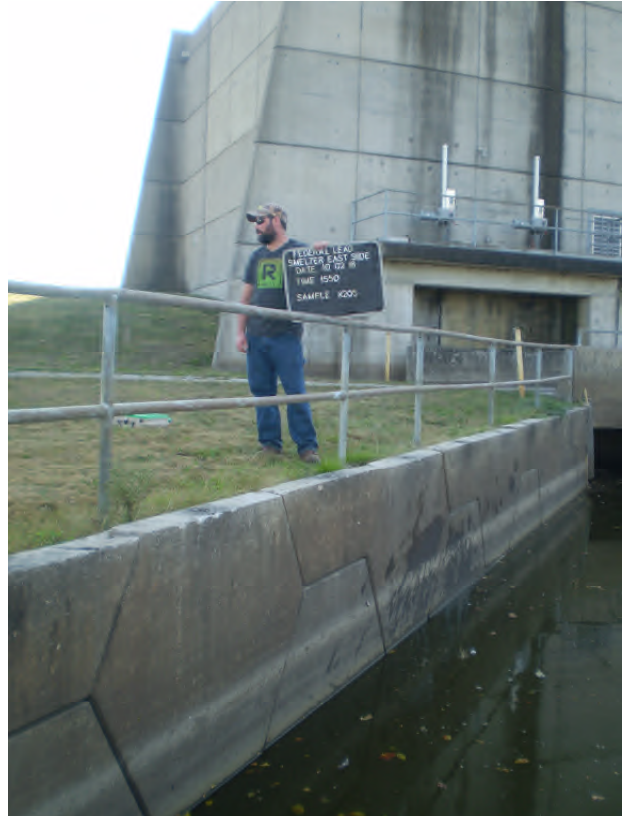
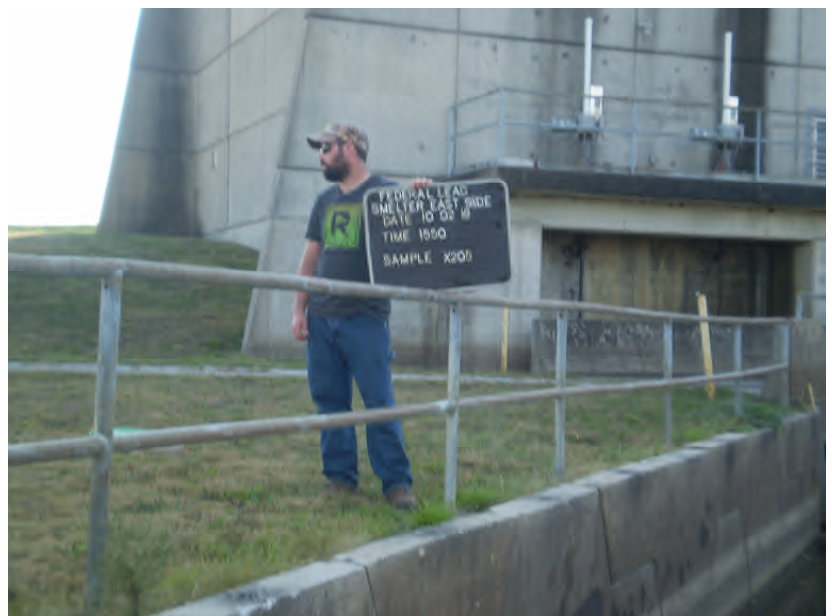
COMMENTS: Sample X205 was collected from the perennial waterway drainage ditch from 0-5 inches.

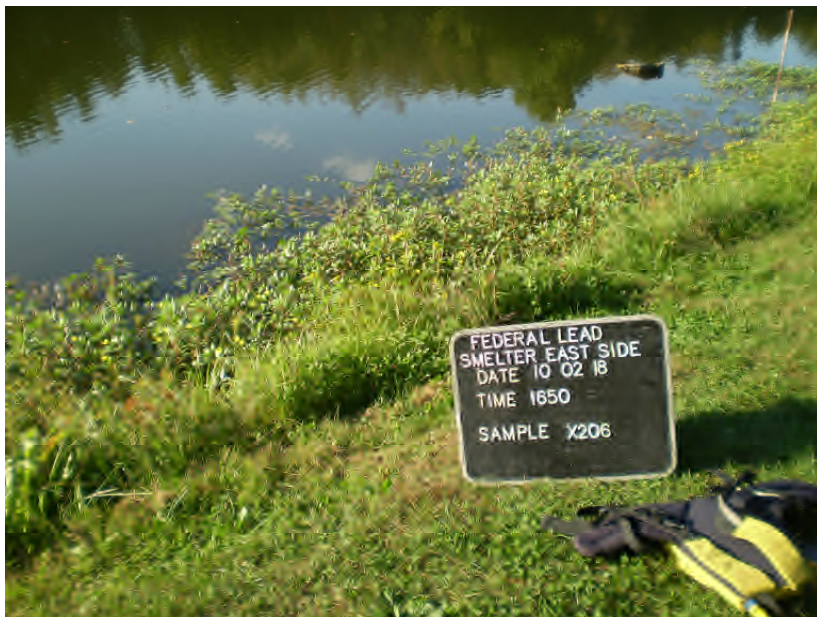
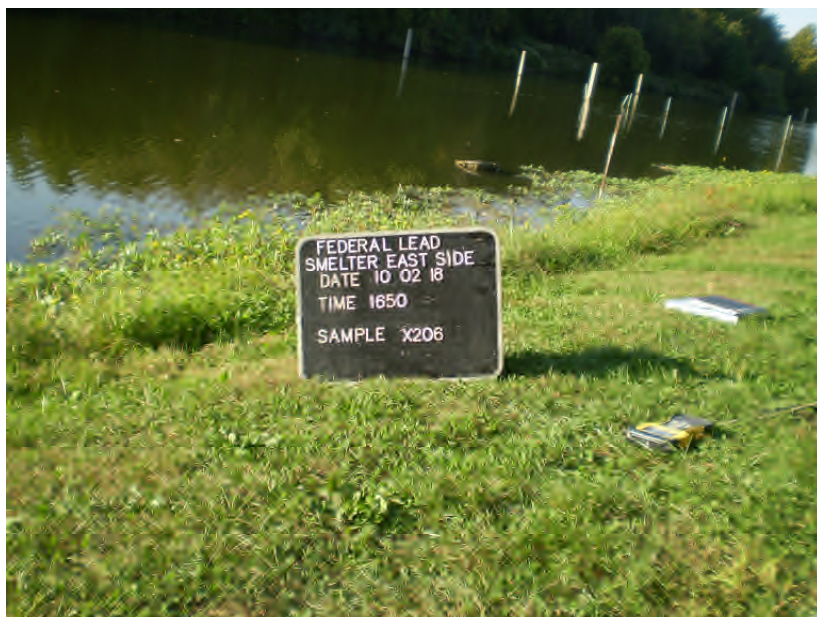
COMMENTS: Sample X206 was collected from the pond located in Alton Park. Used as background sample.
